# Analysis of Strain Gage Reliability in F-100 Jet Engine Testing at NASA Lewis Research Center

Ray Holanda  
*Lewis Research Center*  
*Cleveland, Ohio*

March 1983

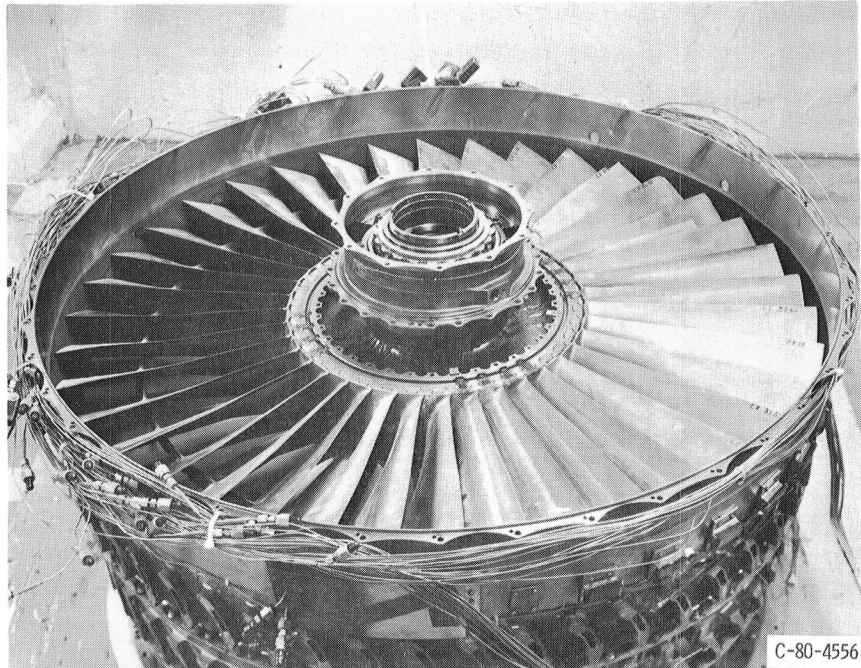
Figure 2. - Instrumented YF-100 engine fan.

Figures 2 to 4 are photographs taken of the fan after disassembly from the engine. Figure 2 presents a view of the entire first stage rotor. The strain-gaged blades can be seen to be arranged in 4 groups of 4 blades each. In figure 3, gage installations can be seen on the convex (suction) side of the blades. A closeup of the blade-to-disk jumps is shown in figure 4. The Chromel-Alumel 28 gage duplex wire can be seen embedded in epoxy cement. Only the first stage gages could be encapsulated in this manner because of the temperature limitation on the epoxy cement. On the second and third stages the blade-to-disk jumps were made with the same wire but were not encapsulated.

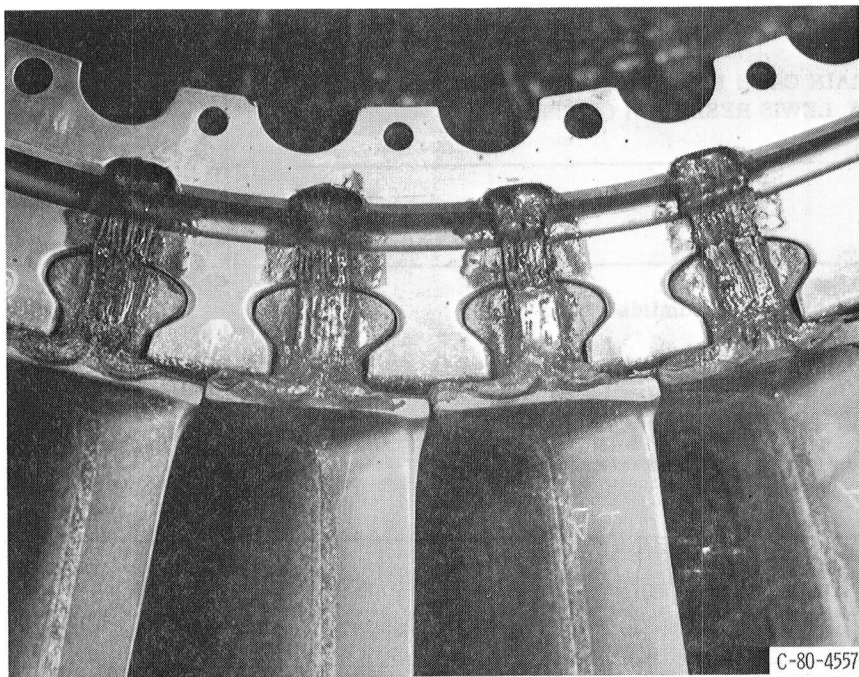
Figure 4. - Blade-to-disk jumps of strain gage systems on first stage of YF-100 engine fan.

There were no jump failures on stage 1, which is the only stage accessible to direct measurement. It was on this stage that the jumps were embedded in epoxy cement. It appears that this technique provided the jump with sufficient flexibility to allow for the relative movement between blade and disk, while at the same time it afforded greater protection than unencapsulated jumps.

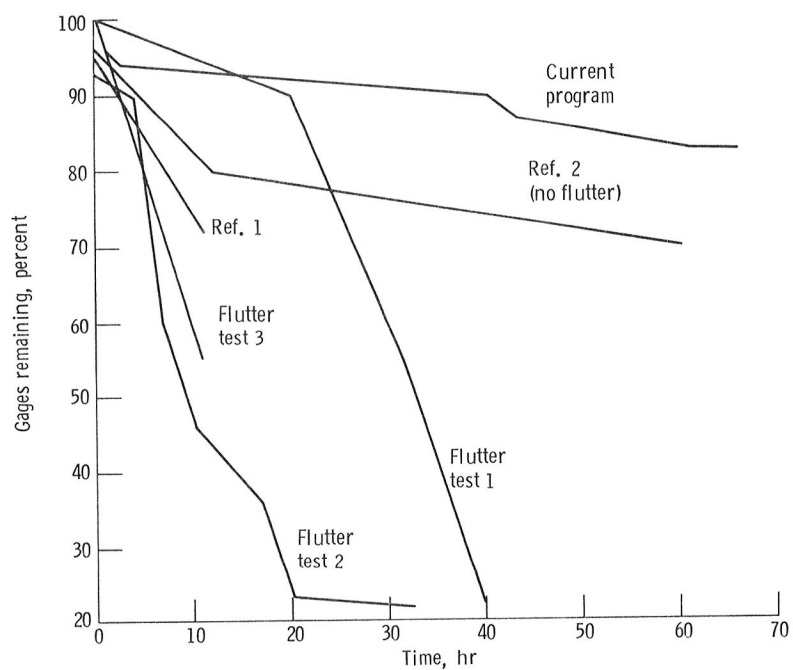
Figure 5. - Strain gage failure rates.

Figure 5 presents failure rate in graphical form. Failure rate curves of previous tests are included for comparison. Flutter tests 1 to 3 preceded the tests of references 1 and 2. Progress is seen to be quite significant during the reliability improvement program. These improvements were achieved even though time in flutter increased dramatically and blade stresses were at least as severe in the present test.
